BUILDING CONDITION ASSESSMENT REPORT

Little Qualicum Hall Building,
1210 Centre Road, Qualicum Beach BC

Submittal Date:
Nov. 27, 2017

HEL Project No. 0837-050

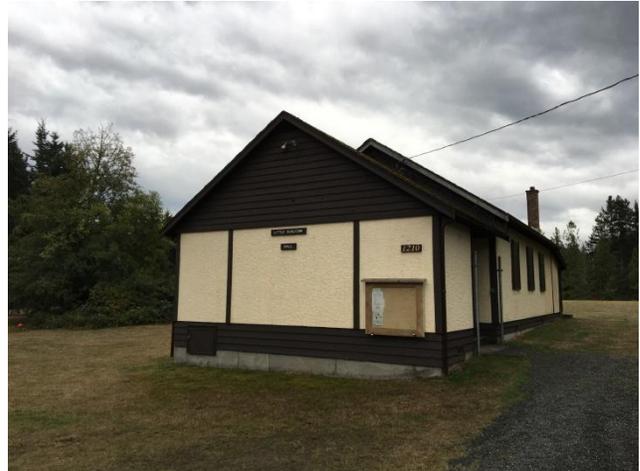
View from front of Hall

The landscaping has a variety of established native plants and lawn.

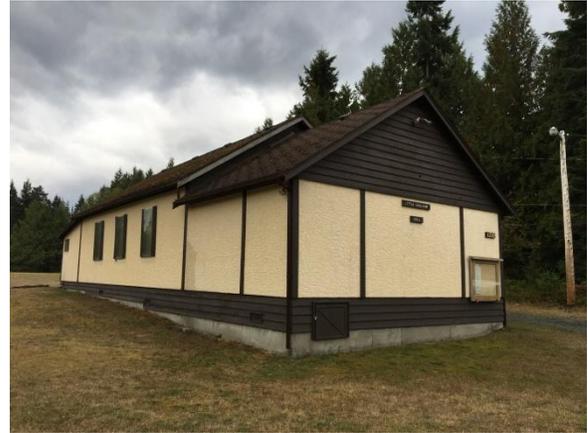
View from front of Hall

The site drainage systems appear to be in serviceable condition, however, rainwater leaders are not directing water away from the foundations and the bathroom/kitchen area is framed within close proximity to the natural grade.

The storm water from the roof should be directed away from the building and into a proper disposal or infiltration system.

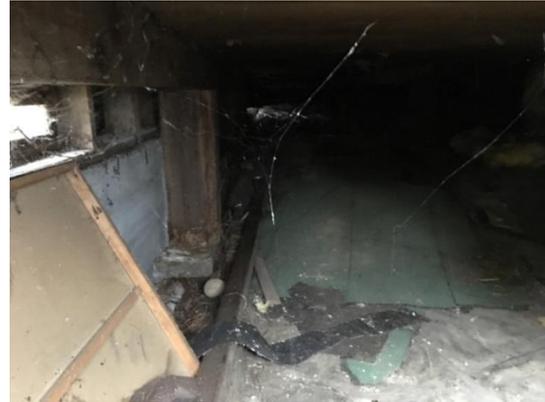
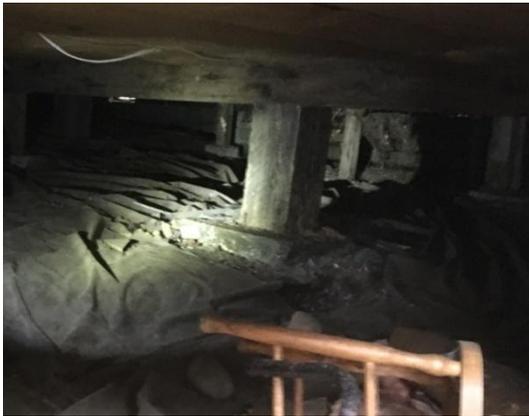
View in crawl space

Where exposed, the primary structure was observed to be in fair to poor condition. There were some areas on the road side or front of the building where the structure was observed to be in fair condition for its age. However, at the rear of the building where the wood structure is located closer to grade the structure is observed to be in very poor condition.

The floor in the bathrooms has structurally failed. The area was not accessible due to the low clearance and debris in the crawlspace. It is our opinion that the washroom floor in the rear corner of the building should not be used by occupants in its current state. Any repairs should be directed by a Professional Engineer to determine the extent of deterioration and appropriate

repairs as the floor system does not appear to be adequately sized for the intended loads.

Furthermore, the entire floor structure is not adequately sized to carry the prescribed BC Building Code live load of 100psf for Assembly occupancy and should be upgraded.

- The wood structure is in need of repairs to the front main hall portion and complete replacement in the rear kitchen and washroom portion. It will be required to redesign, repair and replace the wood structure, dispose of waste and add a new secondary exit at the rear. The bathroom area floor is deteriorated and may require structural joists to be replaced. Demolition of the floor area and a review of the floor framing required prior to reinstatement of any sheathing.

- Remove existing masonry chimney as this is a hazard during a seismic event.
- Double up all joists in the floor system and provide frost cover to the foundations, provide a ground seal to help control moisture.

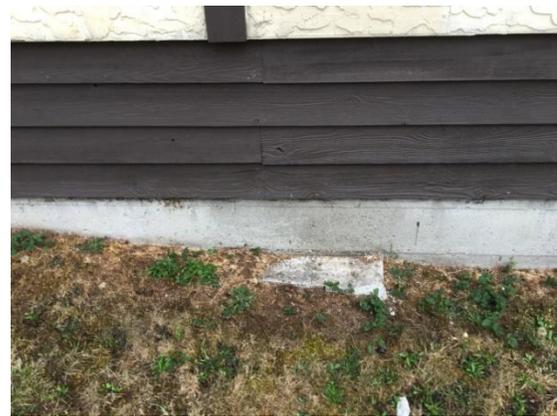
View of foundation

Concrete foundations were found to be in good to fair condition. However, the crawl space is not heated and the foundations do not have adequate frost protection.

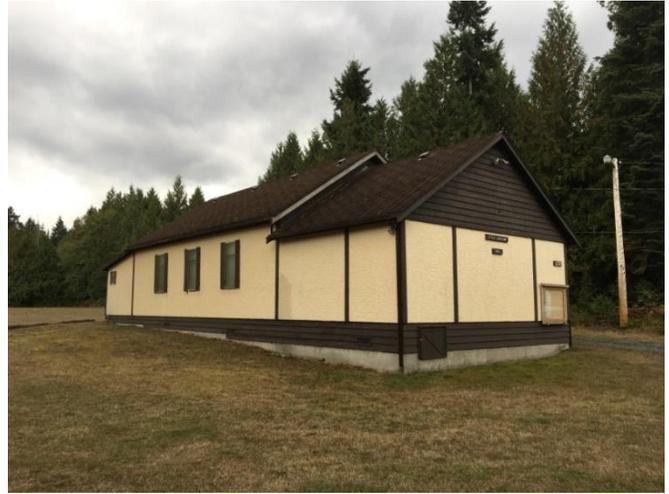
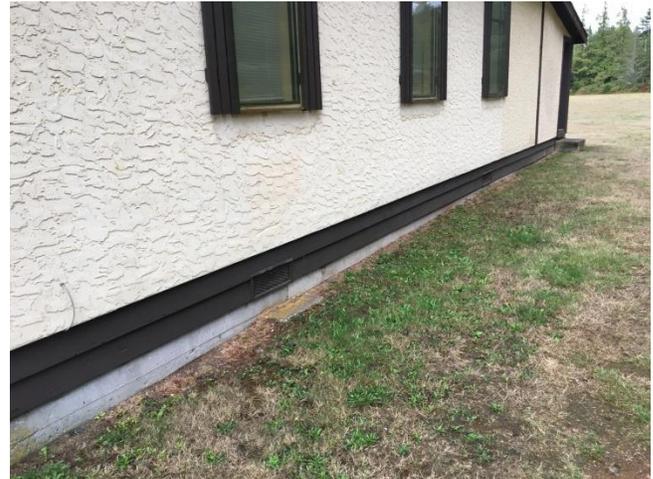
View from front of Hall

View of side of Hall

Generally, the stucco is in fair to poor condition, and nearing the end of its service life. The wood trim and fascias were observed to be in poor condition and appear due for replacement. Stucco Cladding can be an extremely durable exterior wall assembly provided that its performance characteristics are understood. The overall continued performance of the stucco clad walls will depend on periodic review and, if necessary, repair of the cracks and joints.

- The roofing and gutters are in need of replacement. Our observations indicate there is OSB sheathing on the roof that is in serviceable condition.
- The stucco and wood trims are in need of replacement and would be required to be replaced with a rainscreen cladding assembly.

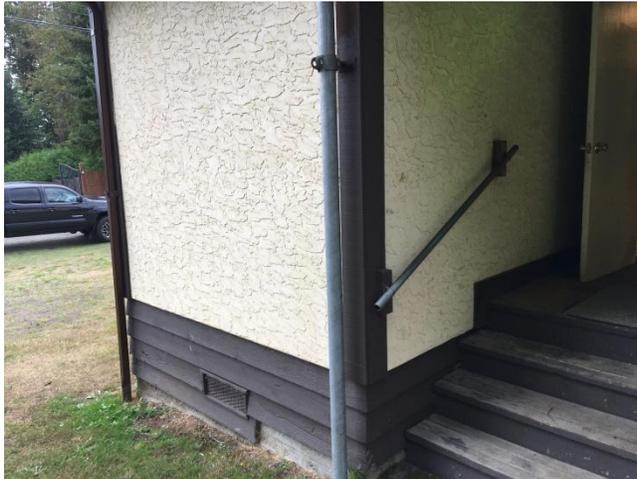
View of handrail at entry stair

The hand rails and exit paths/doors do not meet current BC Building code requirements. Specifically, the exterior door in the kitchen, configuration of the kitchen equipment, and the mechanism to keep the door closed are not conducive to exiting the building in an emergency.

- The building currently has no handicap accessibility. A handicap ramp will need to be added to the new exit at the rear of the building and the front entry stairs and handrails will need to be replaced. The building is in need of a new handicap accessible washroom.

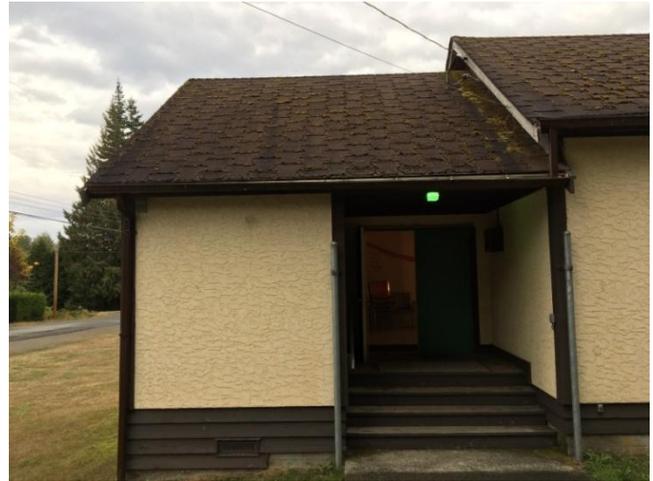
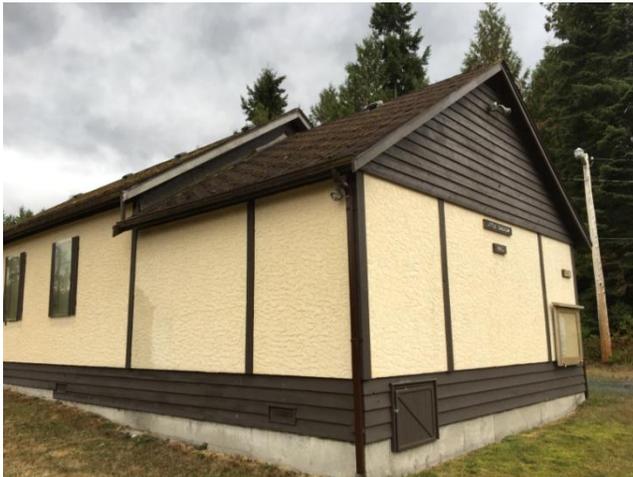
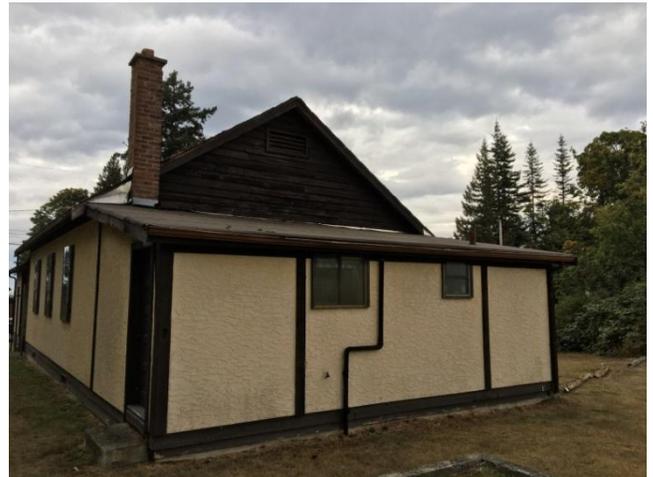
View of roof over entry

View from front of Hall

View of roof over rear of Hall

The roofing consists of asphalt shingles over the main hall and asphalt roll roofing over the rear kitchen and washrooms. The soffits are painted, exposed wood rafters and plywood. The gutter over the front entrance is damaged and does not direct water to the rainwater leader. The rainwater leaders do not direct water away from the building foundation.

The roofing is expired and in need of replacement, the soffits are in need of repairs and repainting. The gutters and rainwater leaders need repair/replacement. Furthermore, we recommend removing or replacing the chimney with a metal one as the current one could be a significant hazard during a seismic event.

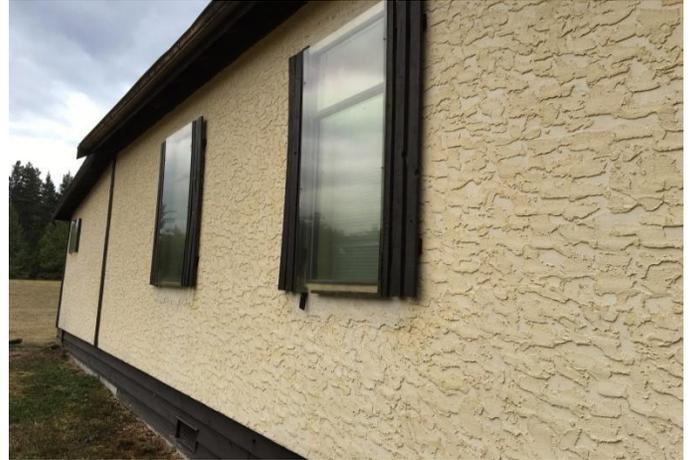
View of side windows

Most of the windows have an exterior plexi glass frame/covering, providing protection which has prevented severe weathering of the windows. While the frames and glazing continue to function as intended they are considered to have a very poor thermal performance with a high level of heat loss during the heating season.

Given the age of these assemblies, it is recommended that consideration be given to the replacement of the existing windows with assemblies that are compliant with current North American Fenestration Standard (NAFS) requirements with respect to thermal performance and air and water penetration requirements. It is advised that the replacement windows be installed in accordance with Best Practices for Window and Door Replacement in Wood-Frame Buildings, publication.

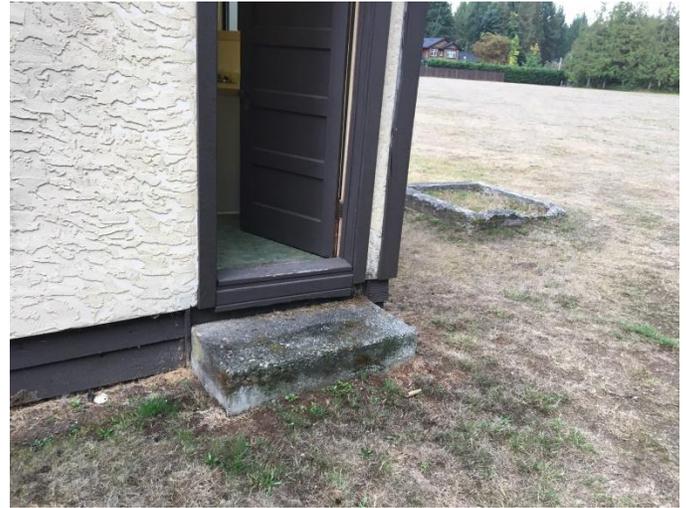
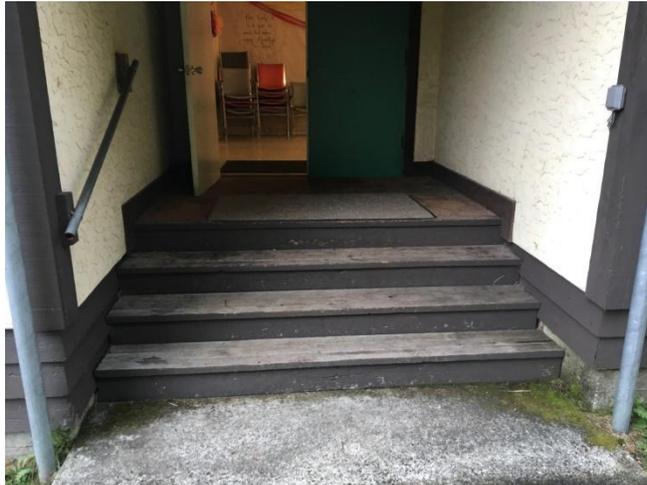
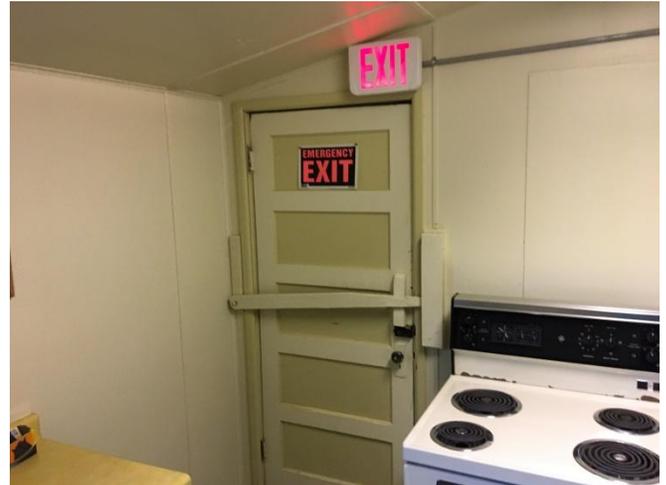
View of rear kitchen door

View of main entry door and stair

View of kitchen door

All doors, frames and hardware are in poor condition and are in need of replacement.

Furthermore, the Building Code requires a minimum of two compliant exits for the intended use of this building.

- The aluminum, non-thermally broken windows and exterior and interior doors have reached the end of their economic service life and will require replacement. We recommend that the Owners consider a replacement program.

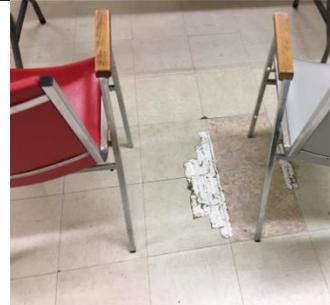
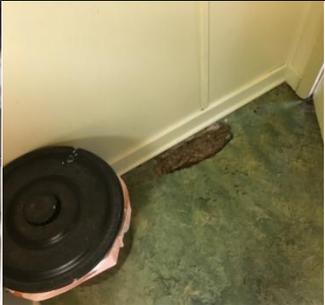
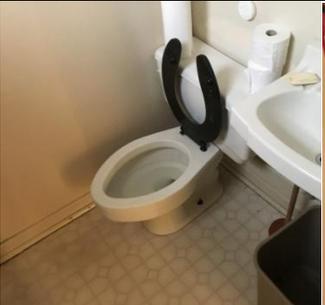
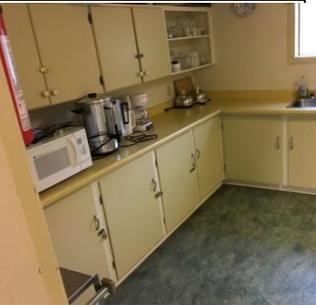
Hall-Flooring	Kitchen Flooring	Bathroom Flooring	Kitchen	
<u>Asset Description</u>				
Interior finishes consist of vinyl tile flooring throughout the Hall. The walls and ceilings are all generally painted wood paneling.				
<u>Observations / Comments</u>				
Interior finishes are in poor condition and in need of replacement. The vinyl tile flooring in the main hall contains asbestos, and the paint is lead based according to the Hazardous Materials Report completed by Lewkowich Engineering and Associates dated March 29, 2017.

- The flooring is in need of replacement and abatement is required of the existing floor coverings.
