May 9, 2018
File: SGL18-016

**Re: Joyce Lockwood Community Park, Gabriola Island
Geotechnical Recommendations for Beach Access Temporary Stair
Repair**

Project: Joyce Lockwood Community Park Stairway Repair
 Project No. SGL18-016
 Date: May 4, 2018

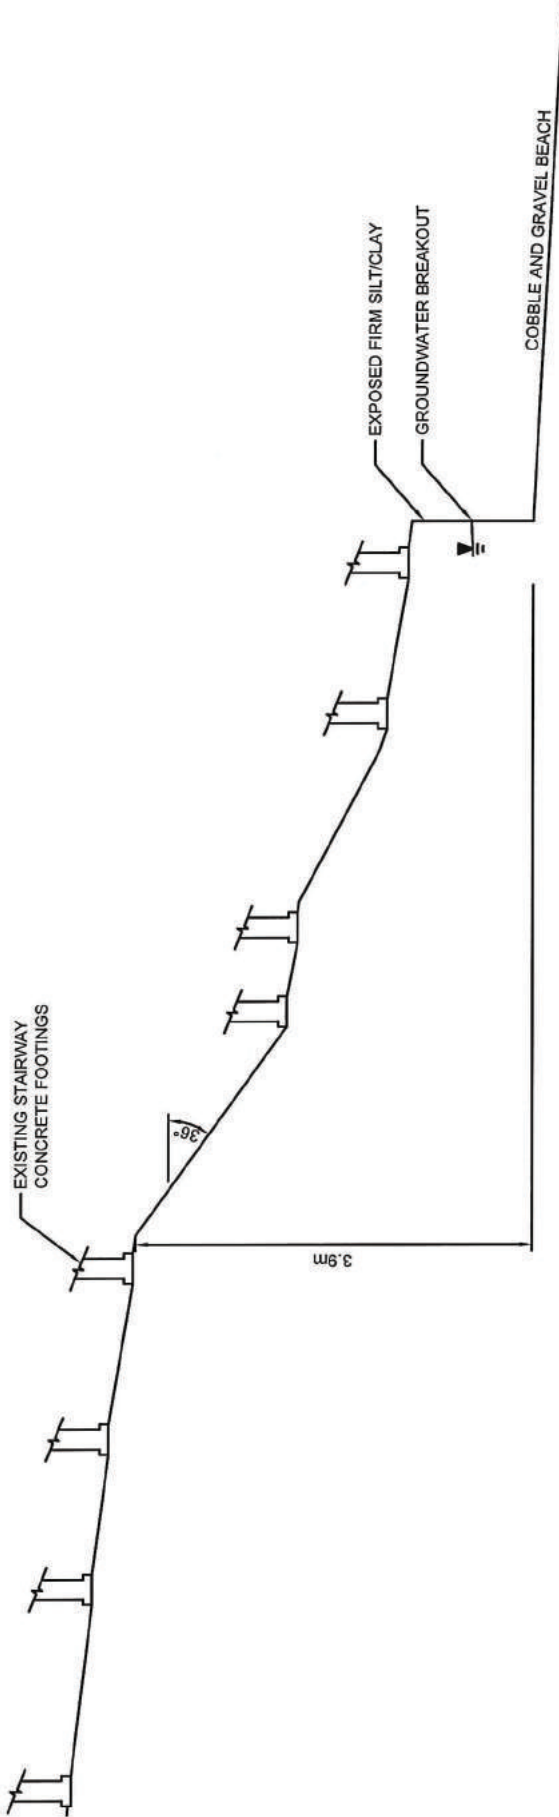
Title: Cross Section A-A through Existing Stairs				
Client: RDN Parks				
File: SGL18-016	Drawn by: RRS	Scale: 1 : 75	Date: May 9, 2018	Dwg. No.: Figure 2

backshore slope through two flights of stairs with two intermediate landings. The final flight of stairs that would have descended from the lower landing to the beach level was absent and was reportedly removed last year due to storm damage. A cross section of the slope surface through the stair alignment was obtained by laser rangefinder and is shown on Figure 2.

geometry shown on Figure 2, with soil properties and groundwater conditions estimated from the soil exposure at the slope toe.

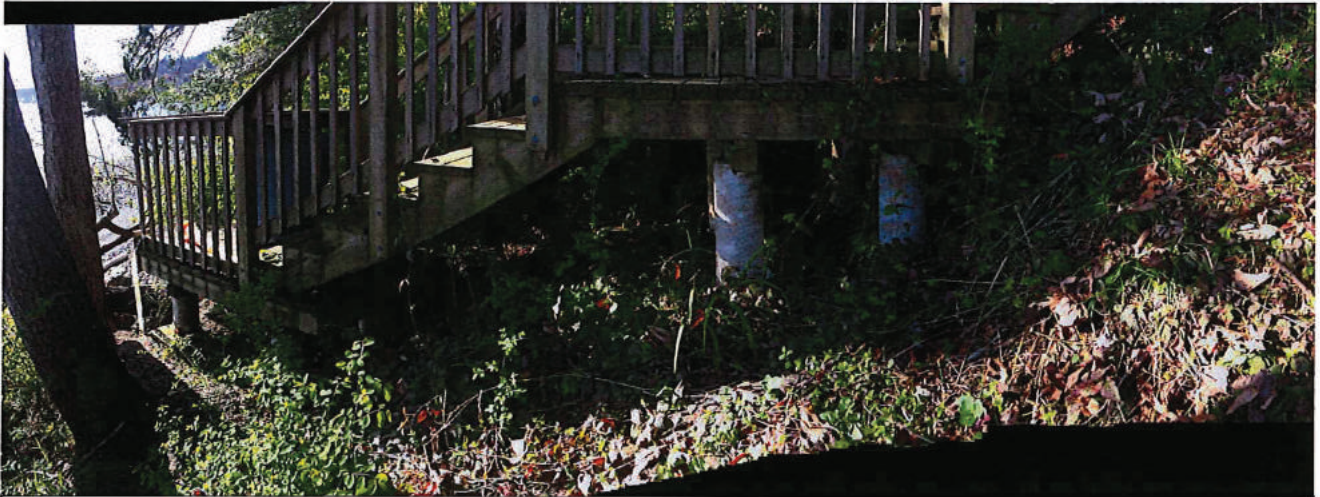
The wooden structure was supported on pairs of 200mm diameter concrete piers bearing on concrete pad footings that bore directly on the ground surface. The stair structure that remained in place was in relatively good condition for its age, with no significant deformation suggestive of slope movement observed.

Photo 1 – Looking southeastward at beach access stairs

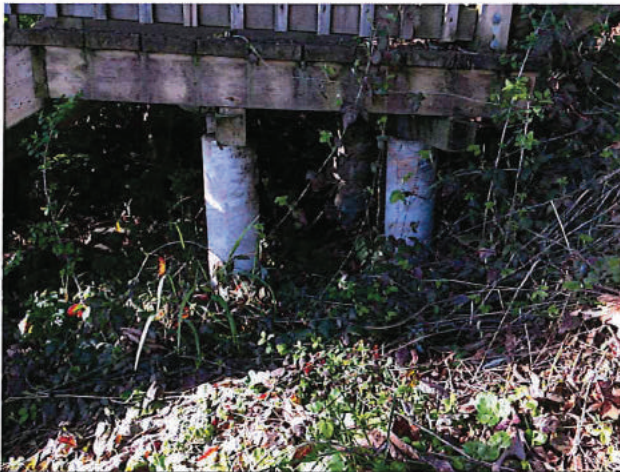
Photo 2 – Concrete pier foundation on upper slope

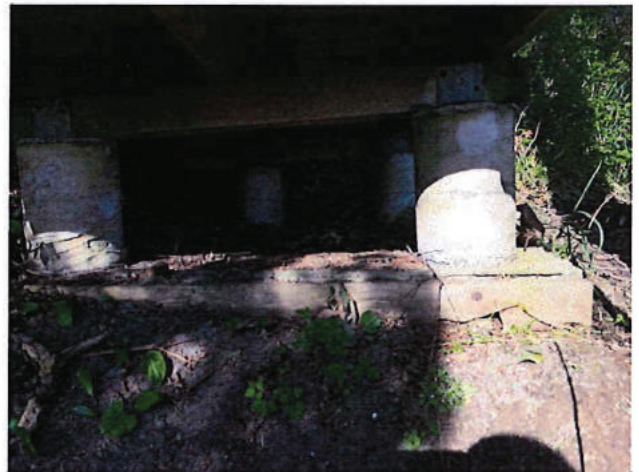
The toe of the backshore slope was eroded by ocean waves to a near vertical 1.2m high slope that exposed soft silt/clay with a trace of fine sand and occasional small gravel. Water seepage was emanating from the eroded slope approximately 0.5m above the beach level. The lowest stair foundation pier was located within 0.3m of the crest of that eroded slope.

Photo 4 – concrete pier foundation on lower slope

Based on our site observations and discussions with you on-site, the lower flight of stairs of the beach access stairway could be restored for temporary use by buttressing the wave eroded slope toe to increase support the lowest existing stair foundation pier and provide stairs from that buttress to the beach level. Those stairs could be designed to retract during storm season to minimize damage from wave impacts.

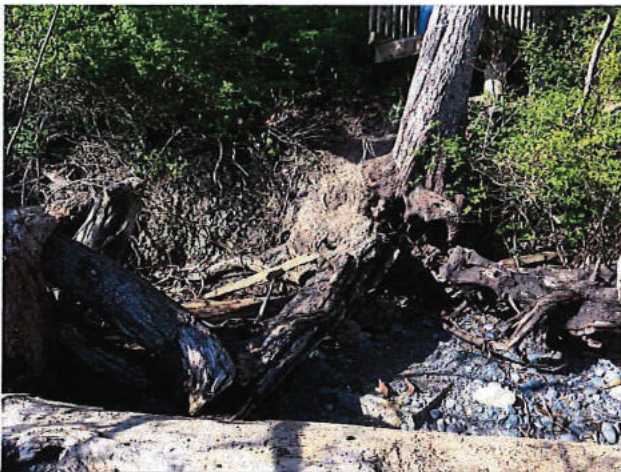
The remainder of the slope above the wave eroded toe was vegetated with primarily conifers with trunk diameters up to approximately 400mm and a low brush understory. Most tree trunks on the slope above the slope toe were relatedly straight to slightly tilted downslope, suggestive of minor surficial downhill slope creep. The trees along the slope toe were predominantly pistol-butted and/or severely tilted downslope, indicative of progressive wave erosion undermining the trees along the slope toe.

Photo 5 – eroded slope toe and tilted trees below remaining portion of beach access stairs

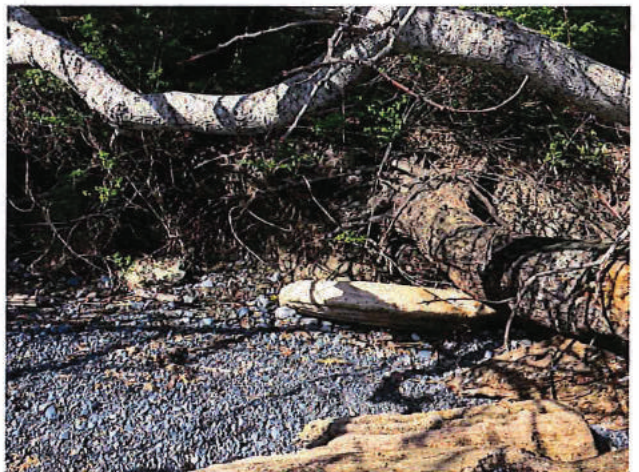
Photo 6 – eroded slope toe and tilted trees below remaining portion of beach access stairs

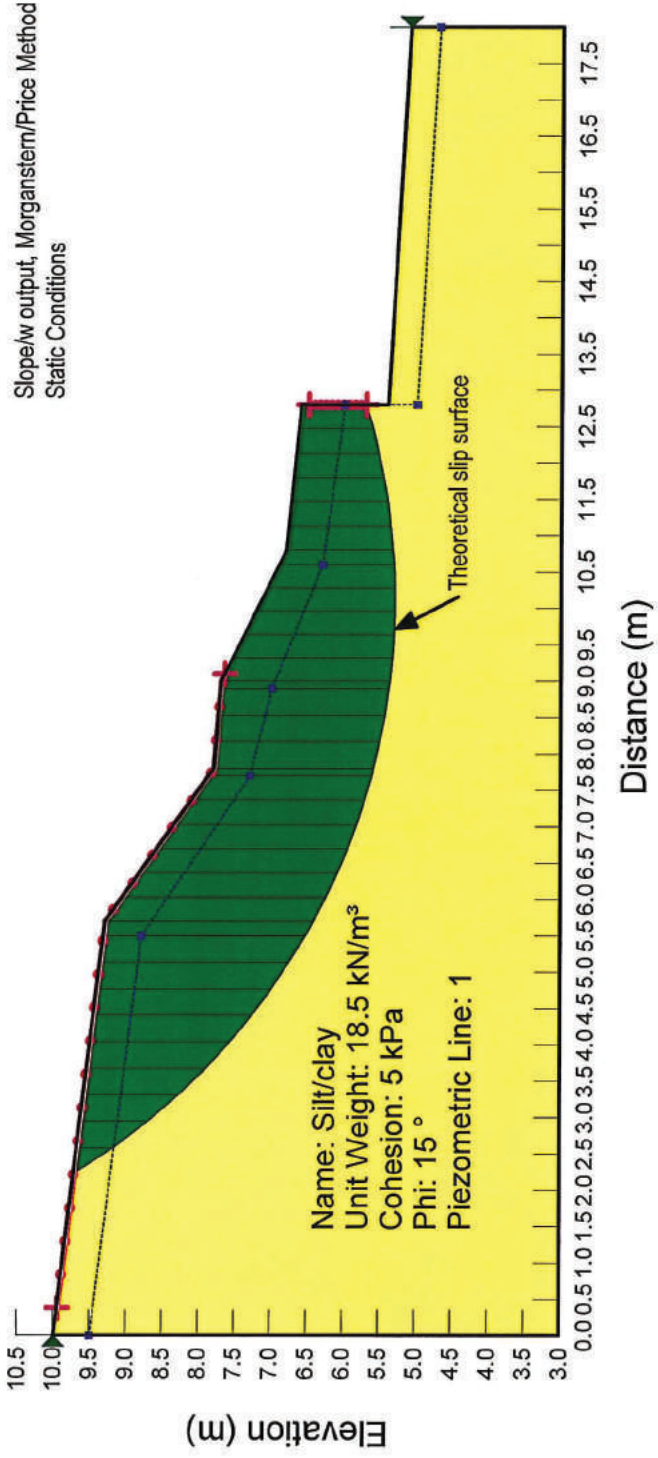
That slope stability model showed that the existing slope has a minimum factor of safety against circular slope movement of marginally greater than 1.0. Output from the slope stability modelling is appended.

Structures are typically not located in areas with a static slope stability factor of safety of less than 1.5. At the existing factor of safety of 1.0, slope movement may occur from relatively minor changes to the slope conditions such as saturation from heavy rain, erosion of the toe, or seismic events.

Factor of Safety = 1.099
