April 19, 2018

Mark Dobbs
Regional District of Nanaimo
1490 Springhill Road
Parksville, BC V9P 2T2

**RE: JOYCE LOCKWOOD PARK BEACH ACCESS STAIRS
FIELD OBSERVATIONS APRIL 12, 2018**

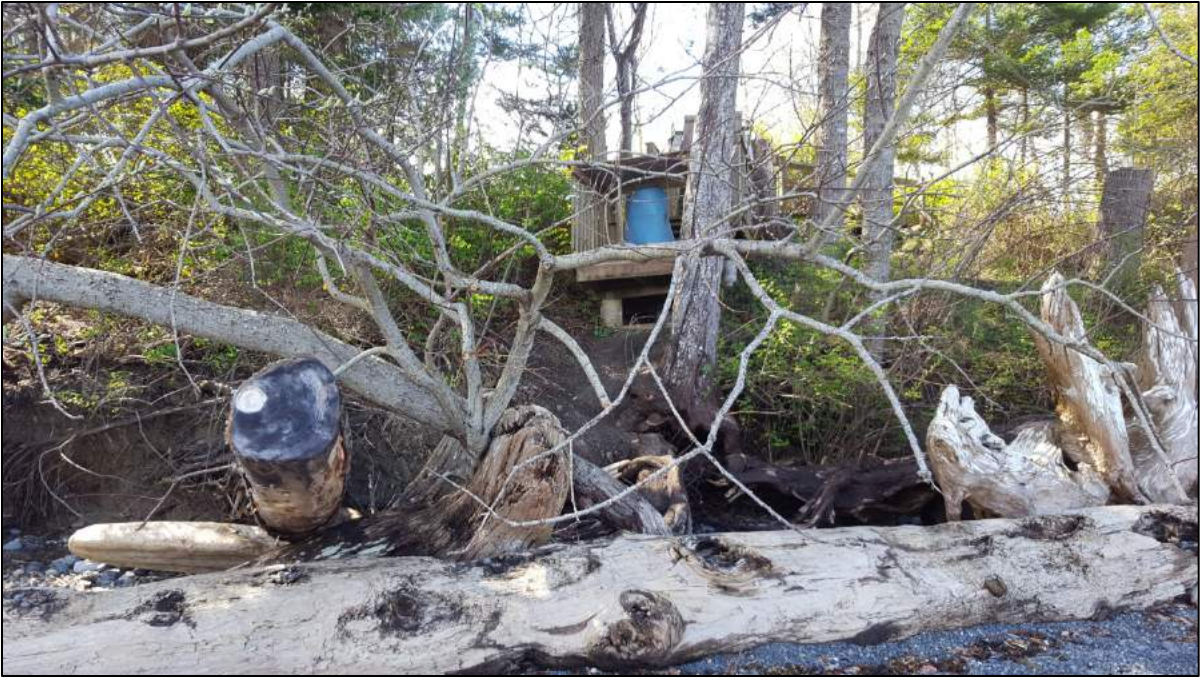
height. The bottom section of the stairs is gone and the stairs are blocked from pedestrian access at the top and what's left of the bottom.

Photo 1. Looking directly at the stairs.

- Because the bank is steep and unstable showing signs of active erosion, a geotechnical engineer should be retained to provide recommendations for the bank and to provide recommendations for the proposed stair reconstruction.

- If possible, design the stairs to span over the slope from the top of the bank to the bottom to avoid additional impacts to the slope. Footings are to be positioned as close to the bottom of the bank as possible (within 1m) to avoid Crown Land tenure requirements.

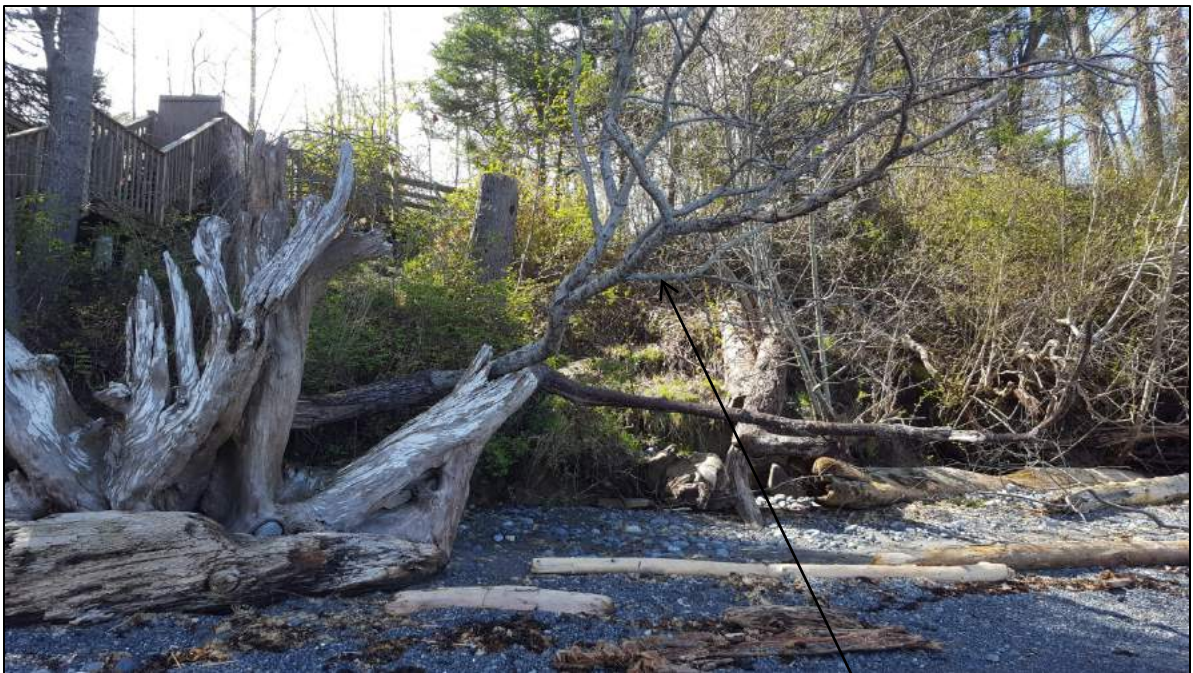
Photo 2. Immediately north of the stairs is a potential alternative alignment.

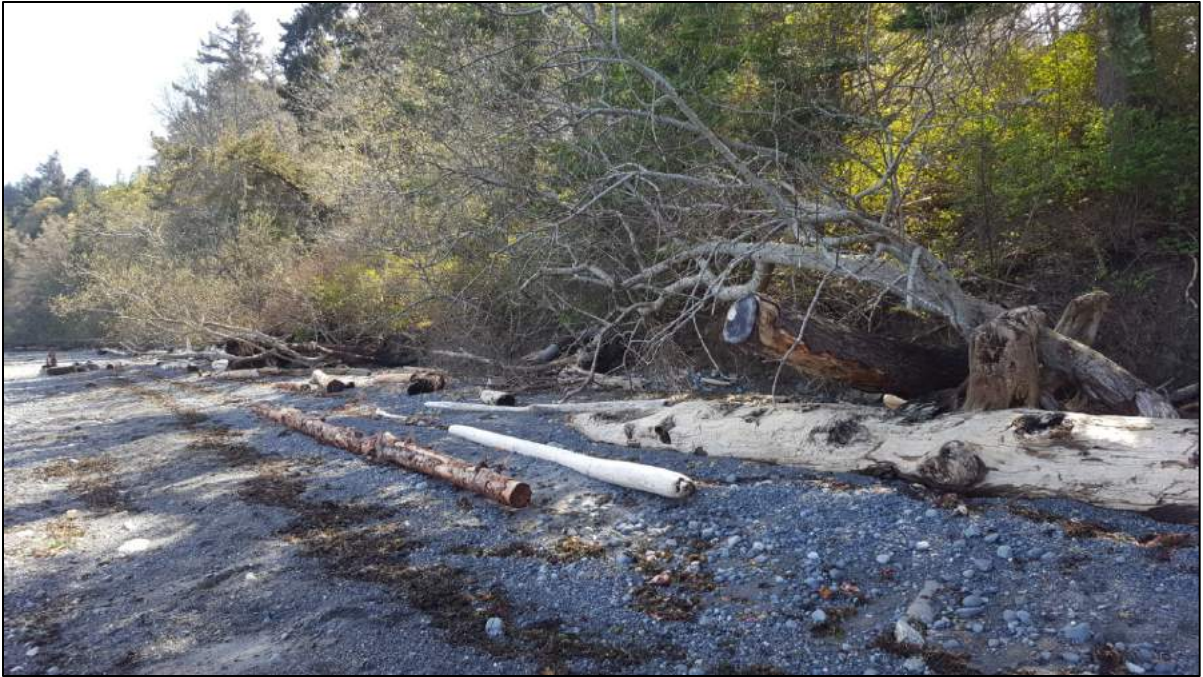
The shoreline is entirely exposed to the Georgia Strait and the bank is comprised primarily of clay soils. The lower portion of the slope for a long distance of the shoreline is eroded forming a cut bank approximately 1.5m high of saturated and seeping clay soils with exposed tree roots. Some of the trees are failing.

Photo 3. Looking south along the shoreline which is showing the same cut bank at the base of the slope all along the shoreline.

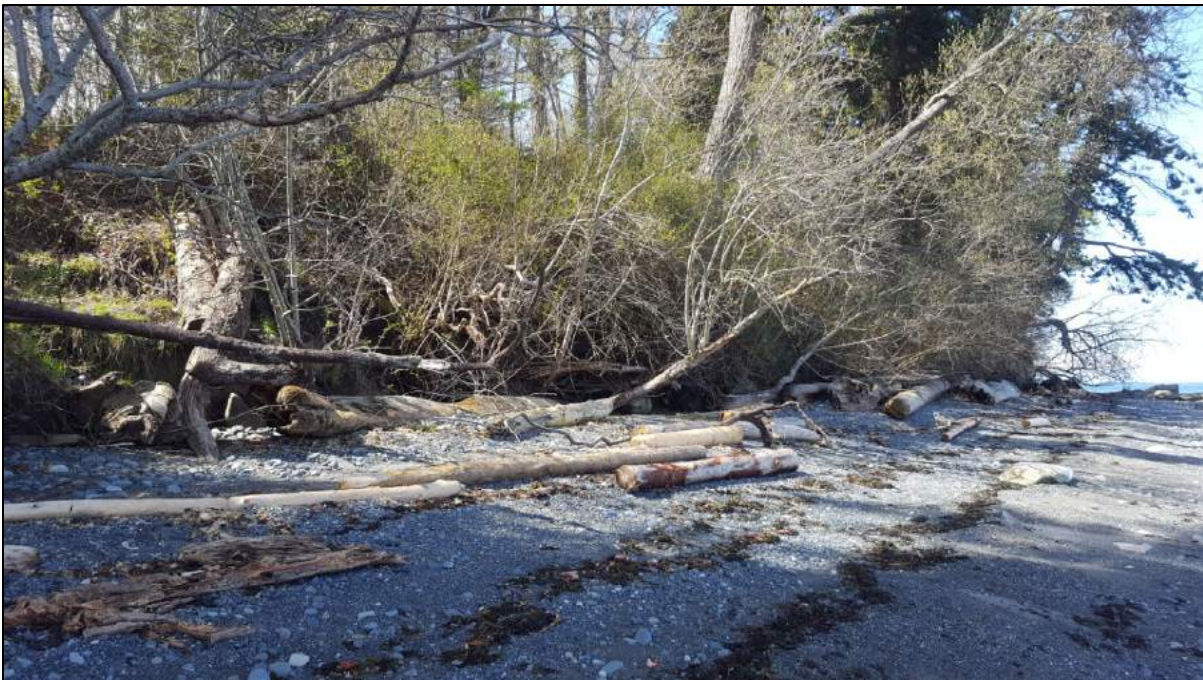
Photo 4. Looking north along the shoreline.

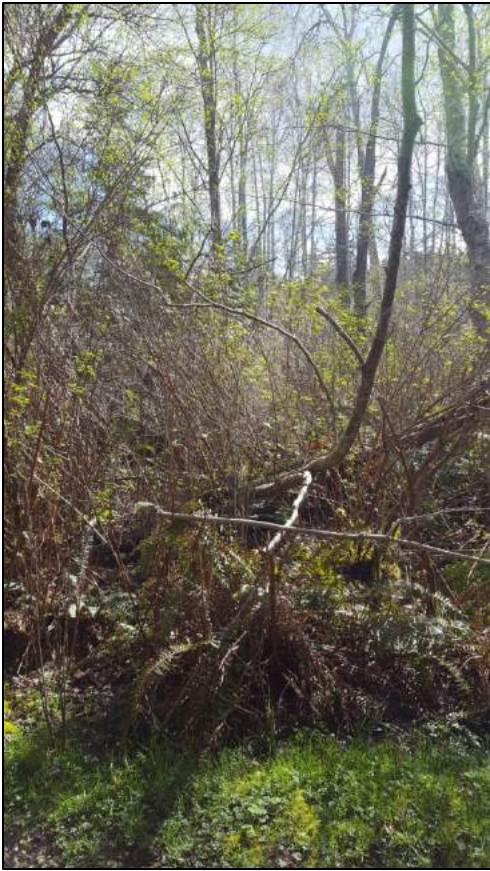
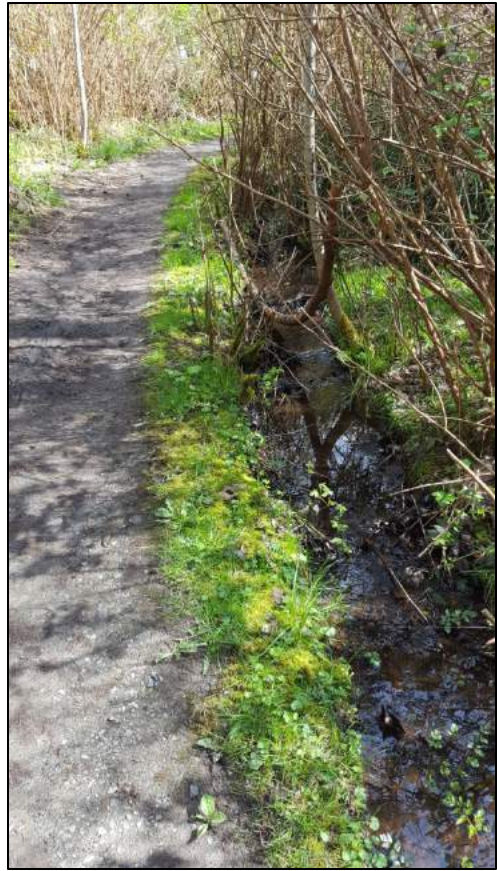
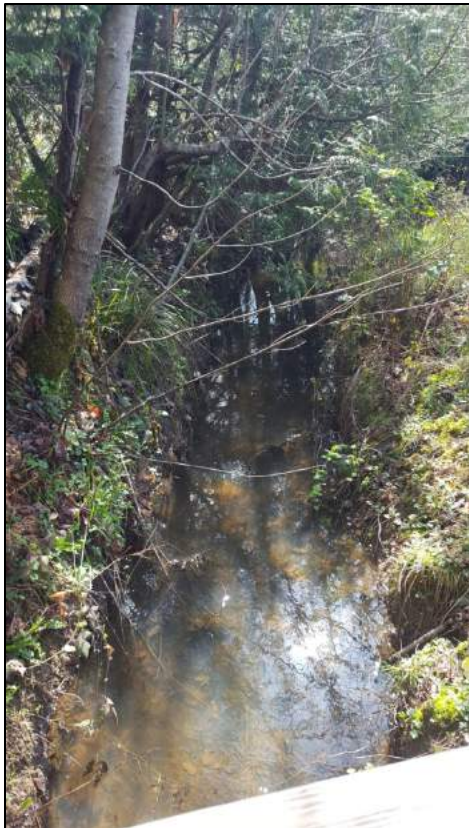
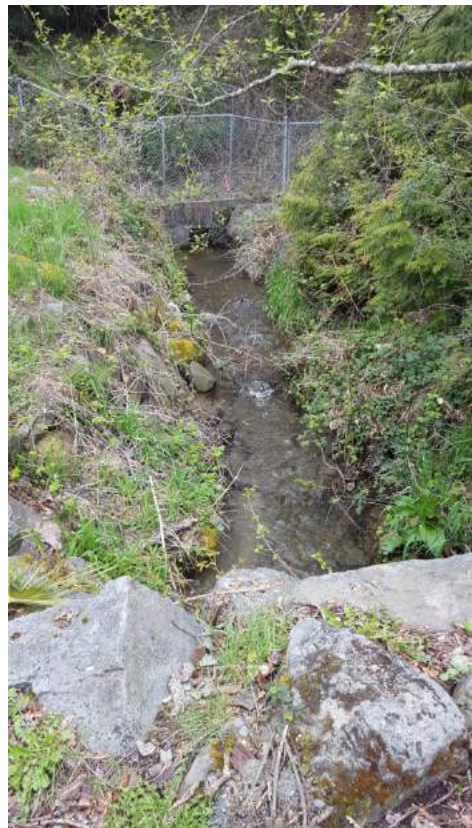
The soils in the upland area of the park and west of the trail are saturated. A small drainage course is located to the north of the stairs on the adjacent parcel that cuts down the bank to the shoreline which is likely also draining the forested swamp located west of the trail.

Photo 5-8. Showing the upslope forested swamp and drainage channels to the ocean through and adjacent to the park.
