STUDY ISSUED FOR USE

To:	Jonathan Behnke (RDN)	Date:	July 7, 2025
c:	Amy Gore (RDN)	Memo No.:	001
From:	O. Sayao and M. Redmond (Tetra Tech)	File:	704-ENG.ACLE03142
Subject:	Descanso Bay Regional Park, Accessible Beach Access Feasibility Study

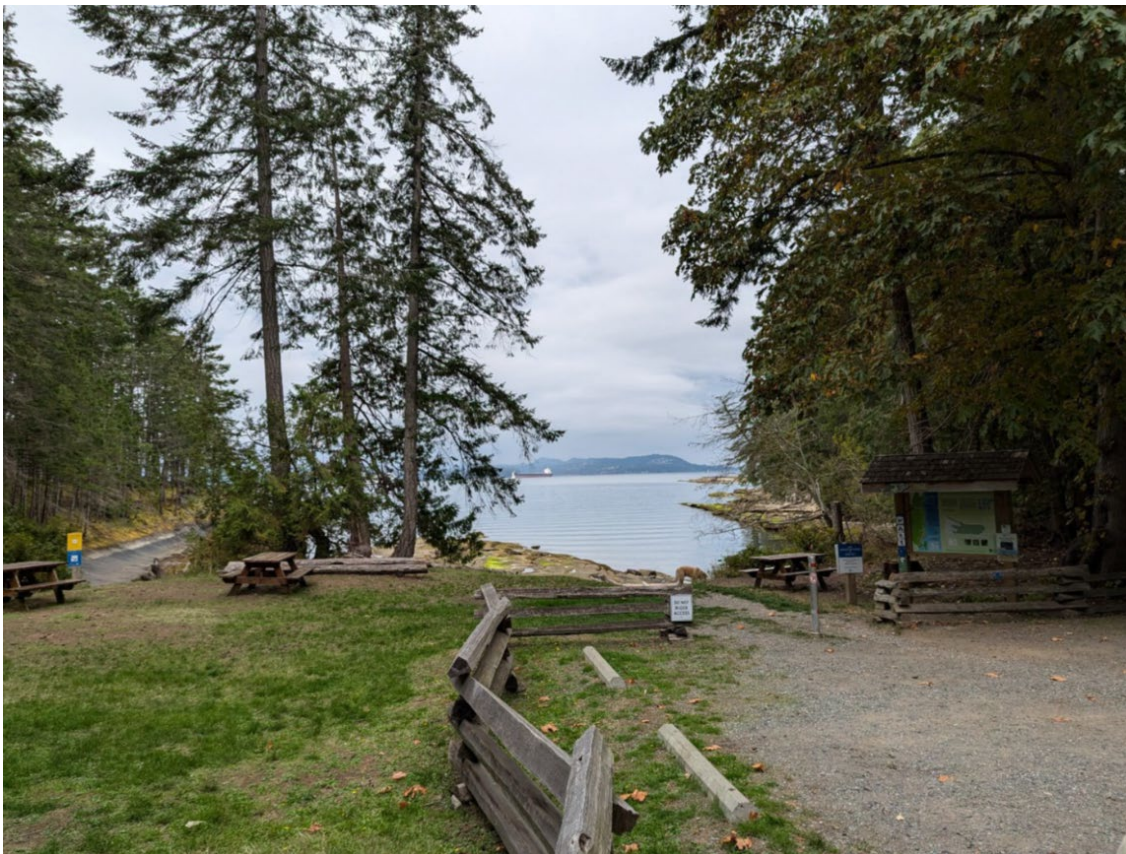
Figure 1: Day Use Area, Descanso Beach Regional Park (Source: RDN, 2024)

Tetra Tech Canada Inc. (Tetra Tech) was retained by the Regional District of Nanaimo (RDN) to conduct an Accessible Beach Access Feasibility Study for the Descanso Bay Regional Park, on Gabriola Island. Figure 1 shows the existing site conditions: the Day Use Area including a picnic area and a parking lot, where presently the beach is not readily and easily accessible for users.

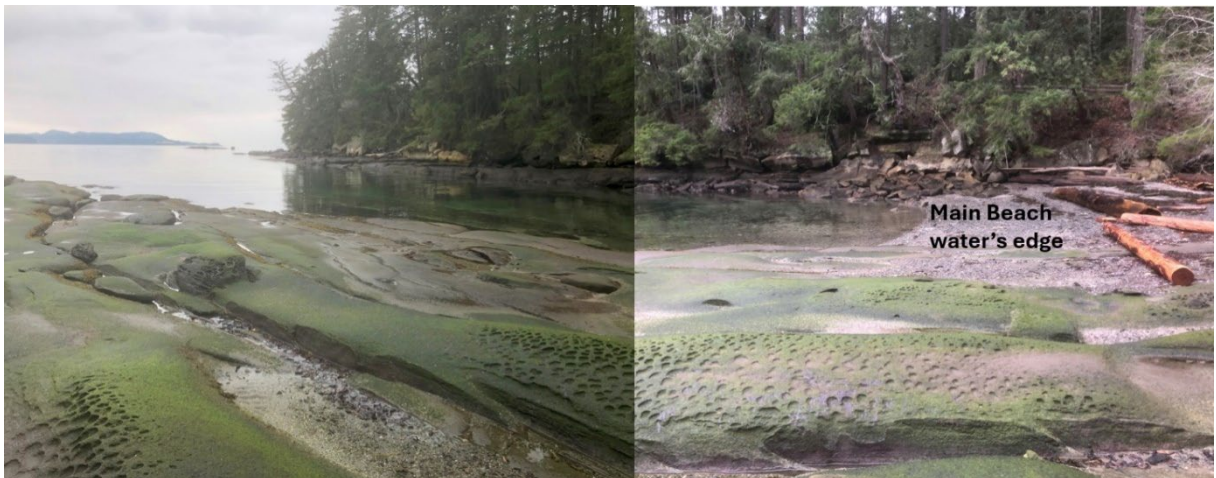
Figure 3: View to the North of the Main Beach and the rocky outcrops and some logs (14/1/25)

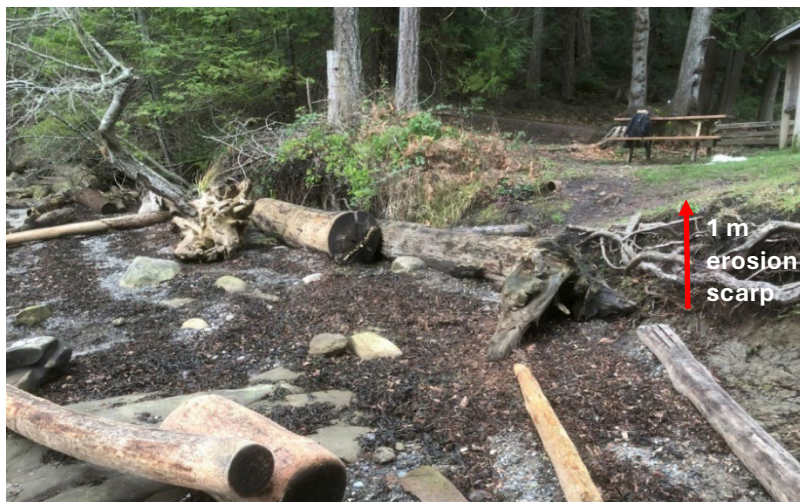
Figure 4: View to the Northeast of the 1 m elevation drop between the parking lot and the beach (14/1/25)

The topographic survey data (03/02/2025) shows elevations at the beach shoreline near the 1 m erosion scarp (Figure 4) of between +2 m GD (+5.1 m CD) and +3 m GD (+6.1 m CD). It is also noted that logs at the beaches were brought in during high tides levels and strong windstorms from the W-NW and reached these elevations, near the erosion scarp.

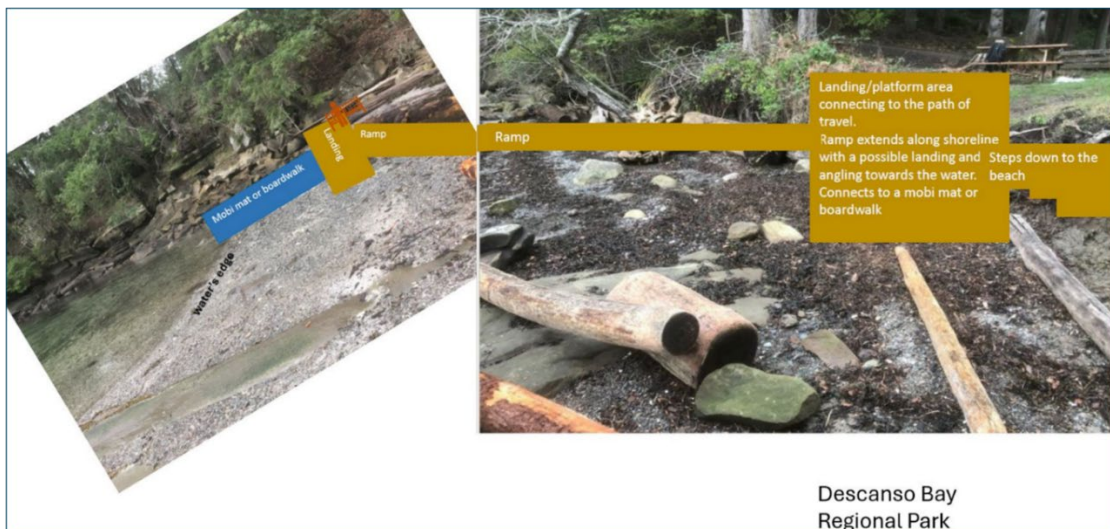
Figure 6: Initial concept of ramp for the Day Use Area Main beach

The initial report from Meaningful Access Consulting providing conceptual ideas for the ramp is included in Appendix C. Figure 6 shows a sketch of the initial ramp concept.

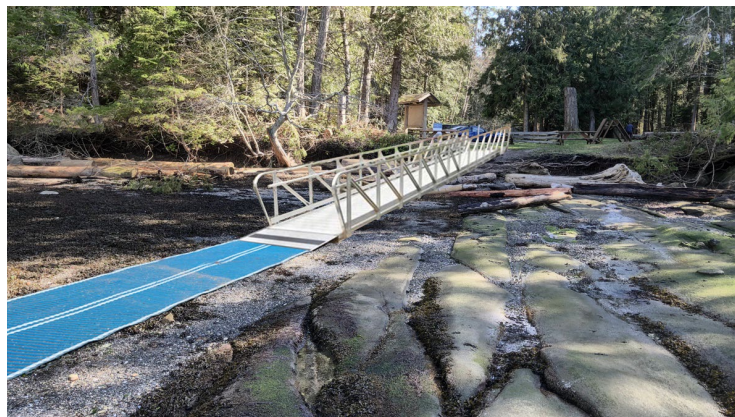
Figure 7: Artistic concept of ramp for Descanso Bay beach (Ref.: GaLTT, 2023)

Other alternatives for the ramp access provided by RDN, based on a 2023 study from Gabriola Land & Trails Trust (GaLTT, 2023), were discussed with the Tetra Tech team and Meaningful Access Consulting. An example is shown in Figure 7. However, the 2023 alternatives do not follow the Meaningful Access Consulting guidelines (Appendix B) for an accessible beach access ramp.

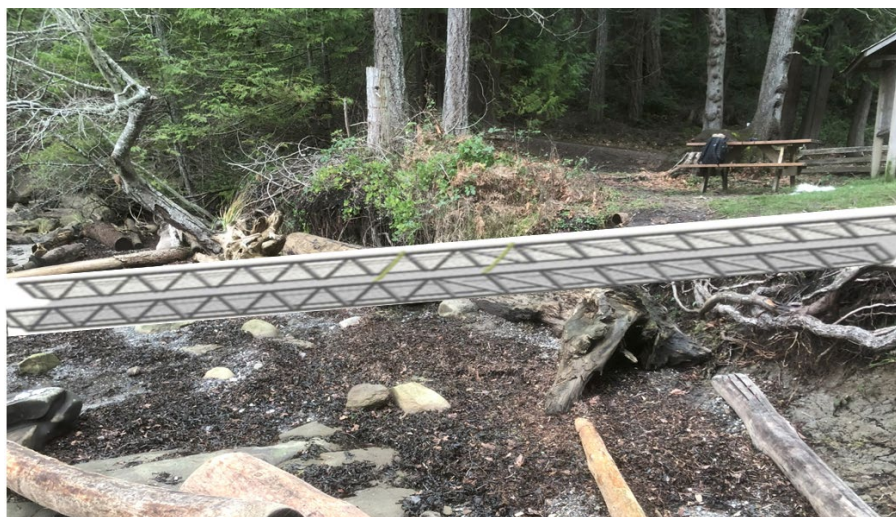
Figure 8: Impression of proposed ramp for Descanso Bay beach

Following the ramp guidelines by Meaningful Access Consulting (Appendix B), a ramp concept using an available marine gangway design was considered, from an USA manufacturer (Topper Industries, Woodland, WA), as shown in Figure 8. The conceptual design drawings are included in Appendix D.

Several alternatives for ramp materials were discussed by the Tetra Tech team, including compacted soil, treated wood, concrete and aluminum. The compacted soil alternative would include excavation and could be impacted and damaged by wave action. A treated wood ramp would potentially become slippery and could decay when exposed to weather and temperature variations. A concrete ramp was not considered due to aesthetics and costs. Thus, the selected alternative was the use of an aluminum ramp.

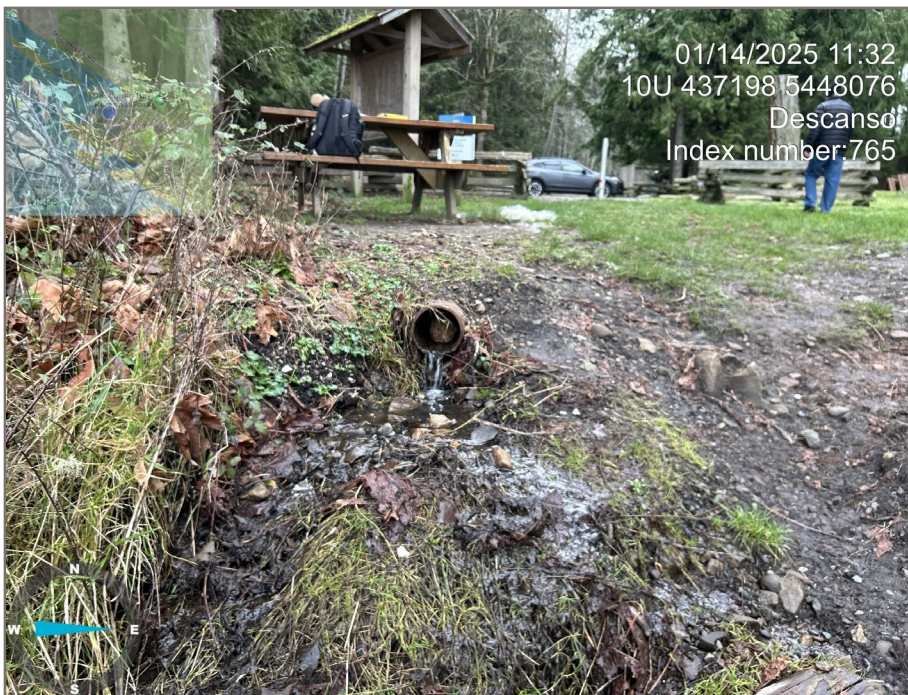
Photo 2: A drainage pipe has been installed below the parking area that conveys water from upstream drainage to the foreshore area. January 2025.

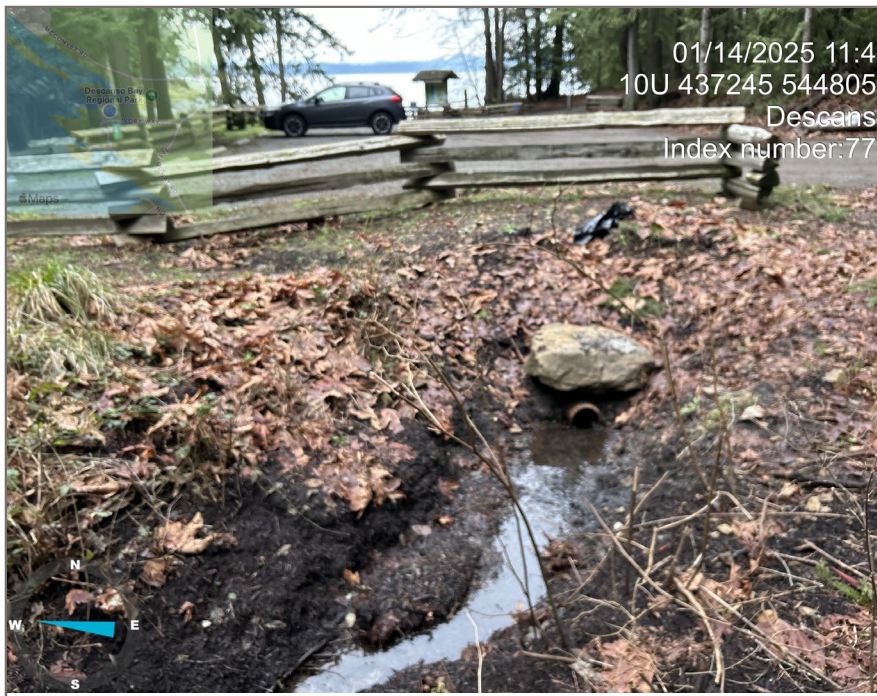
Photo 3: A western view of the upstream drainage pipe (foreground) and the parking lot (background) leading to the main beach access point (far background). January 2025.

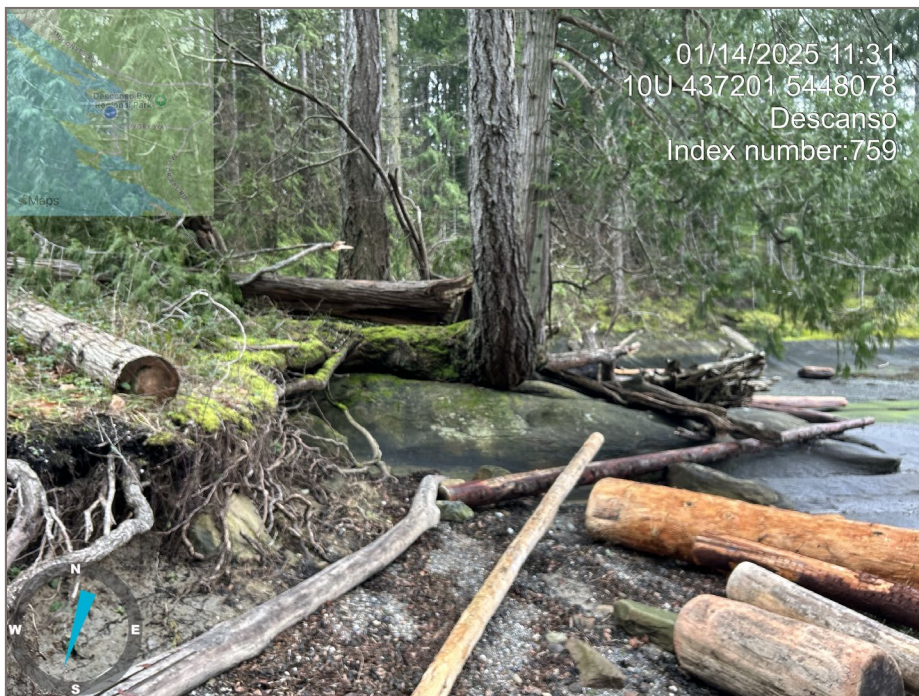
Photo 6: A southern view from the main beach towards the southern beach. The center of the photo shows Douglas Fir trees growing overtop of exposed bedrock. Shoreline erosion of the main beach is evident by exposed roots vegetation overhanging the foreshore.

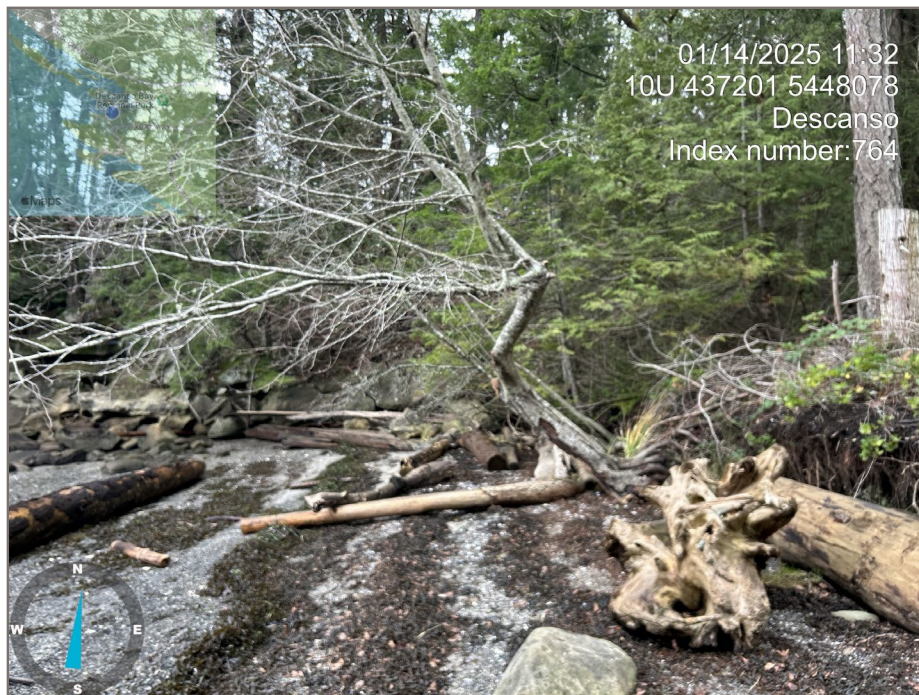
Photo 10: A northern view of the main beach shoreline from the just in front of the current access path. Evidence of macroalgae deposition and large woody debris. January 2025.

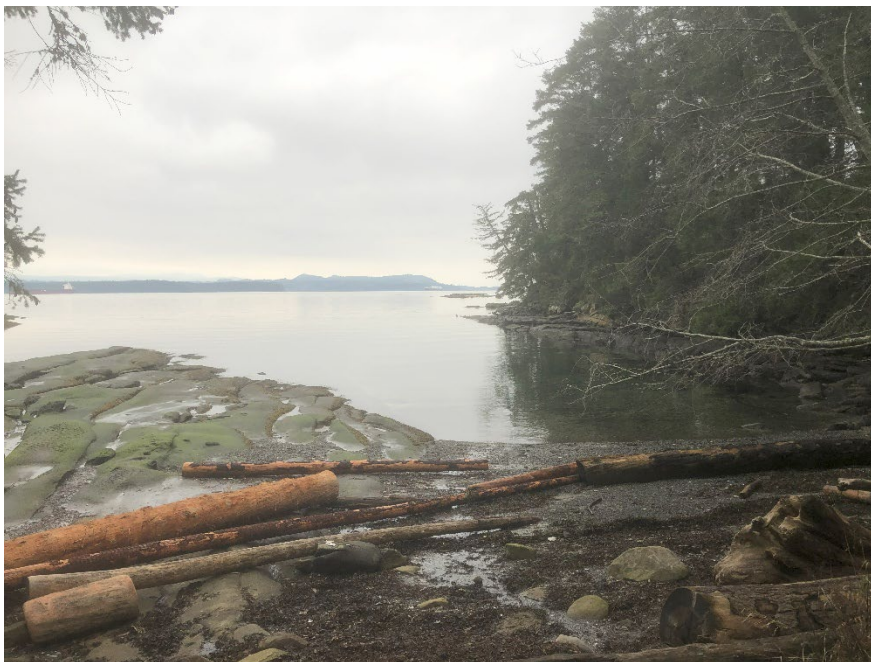
Photo 12: A view of the main beach towards the Northwest showing the wind fetch over water. January 2025.

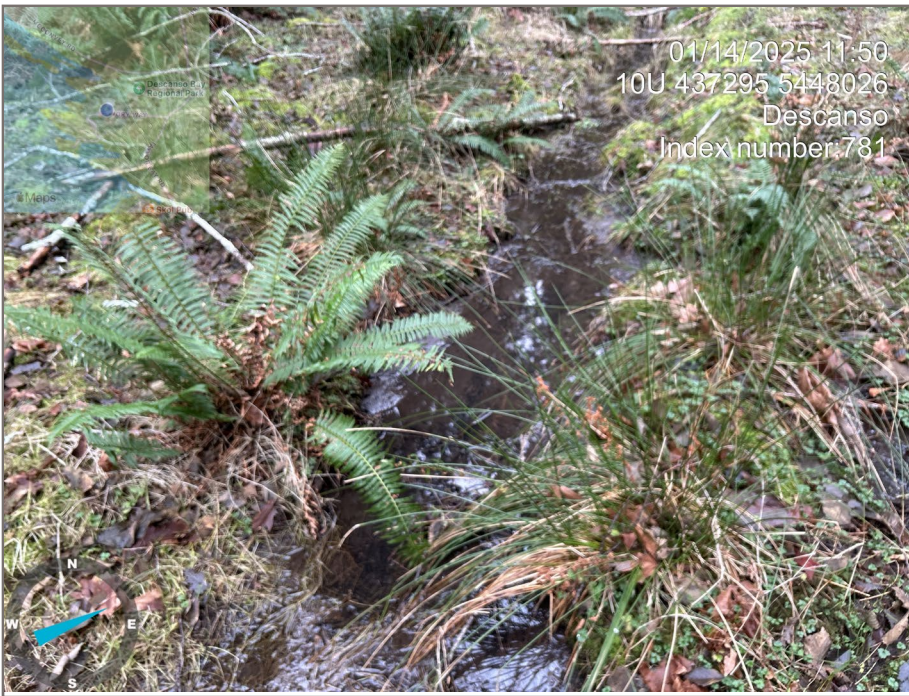
Photo 14: Water draining from a nearby catchment towards Descanso Beach. January 2025.

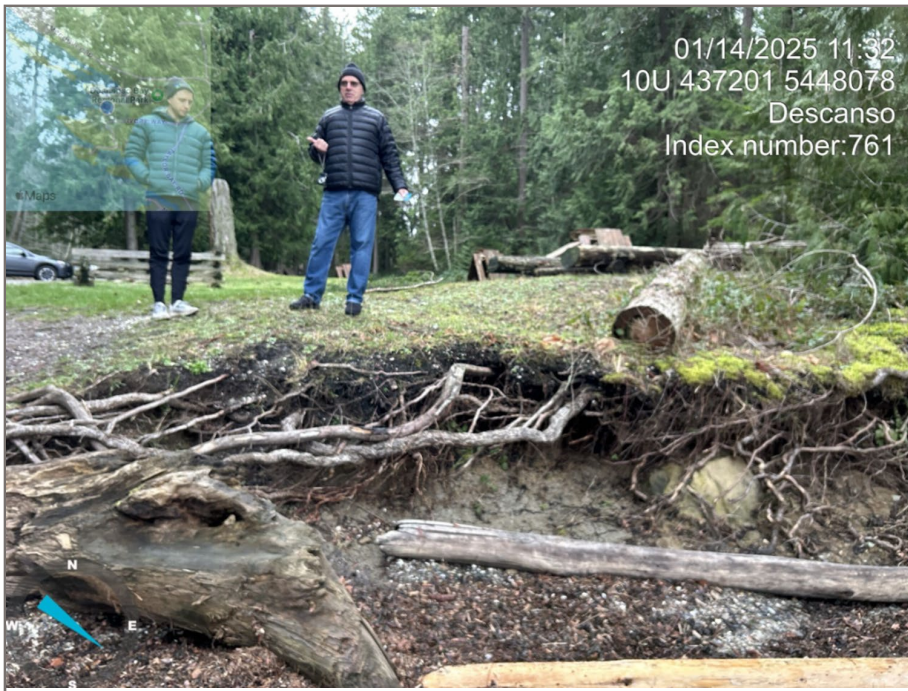
Photo 16: View to the East of the elevation drop and the erosion scarp near the main beach where the ramp would be conceived. January 2025.

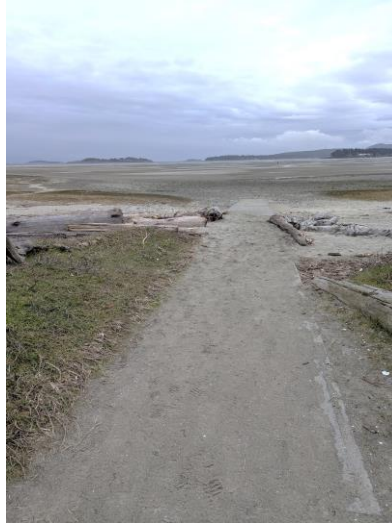
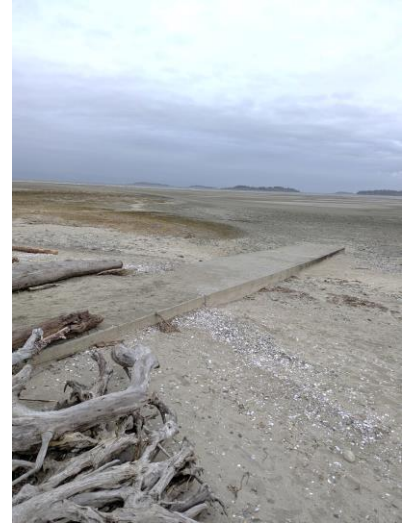
The adjacent photos are examples of a low-grade ramp that is found in Rathtrevor Provincial Park. In the summer, the ramp is extended with the use of a mobi-mat for greater access to the beach floor.

Photo of beach access ramps located at Rathtrevor Provincial Park
Photo credit: Karin Pasqua

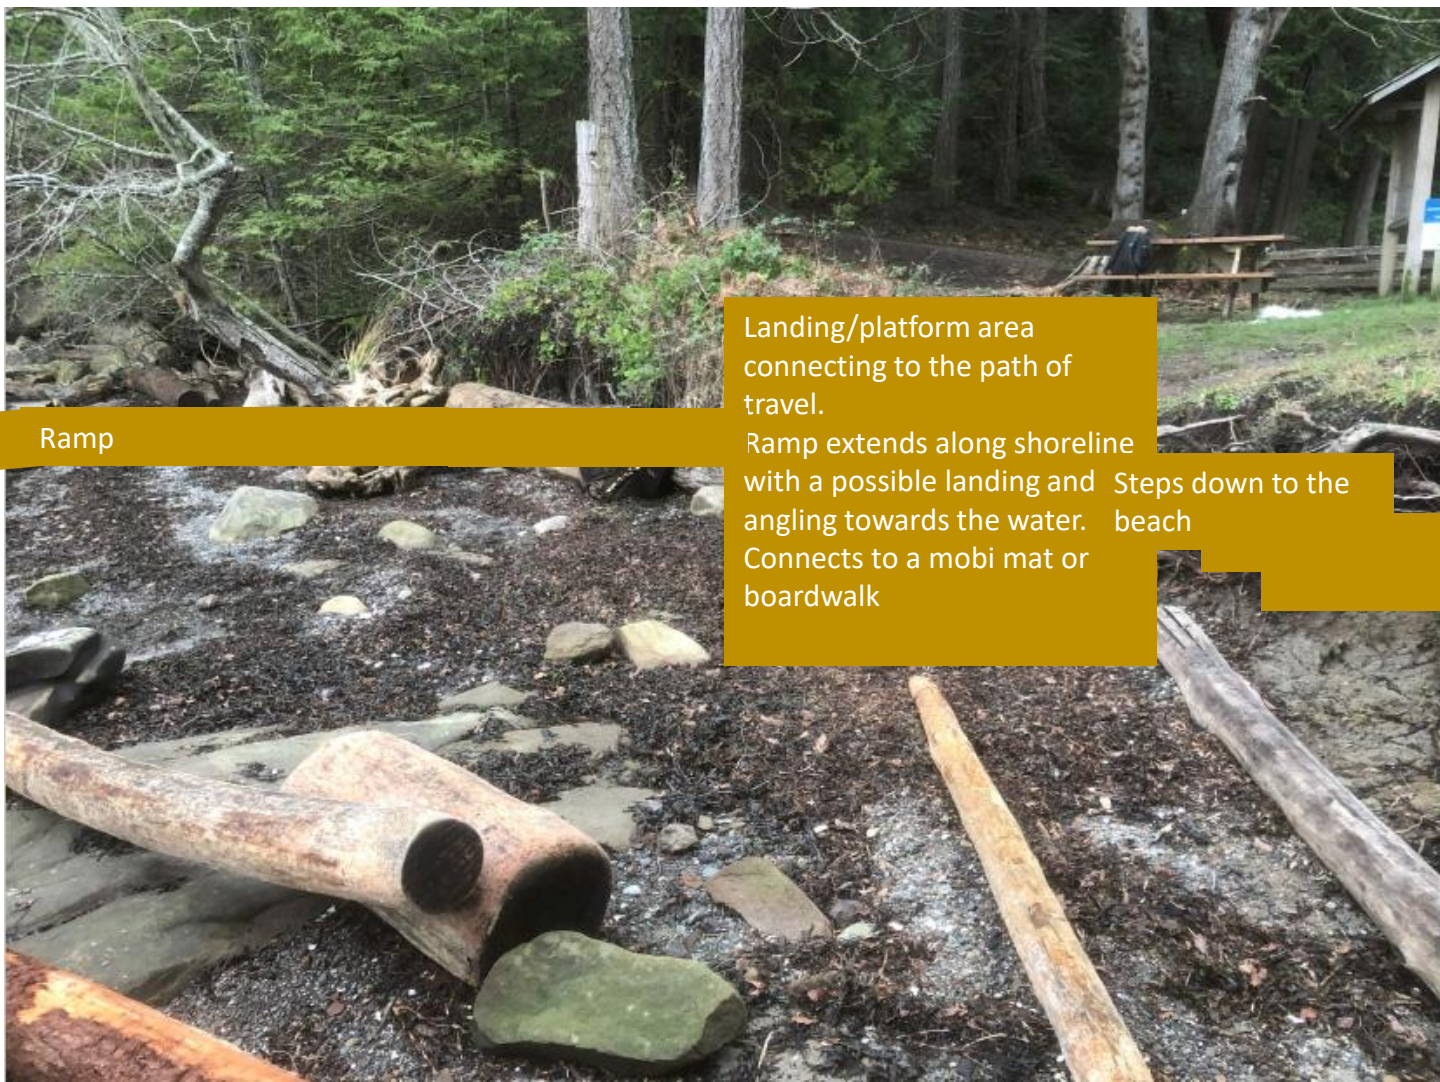
Landing/platform area connecting to the path of travel.

Ramp extends along shoreline with a possible landing and angling towards the water. Connects to a mobi mat or boardwalk

Steps down to the beach
