Images of the Bonnington-Coventry corridor

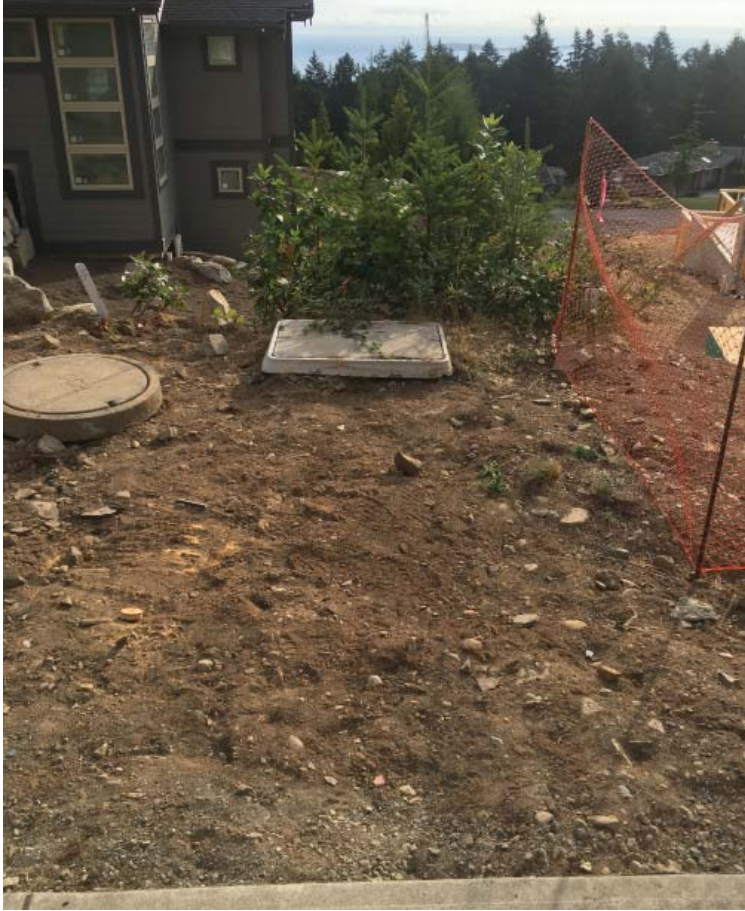
Image 1 (left):
Hydro, Tel, Cable infrastructure
at top (Bonnington Dr.) end of
park land corridor.

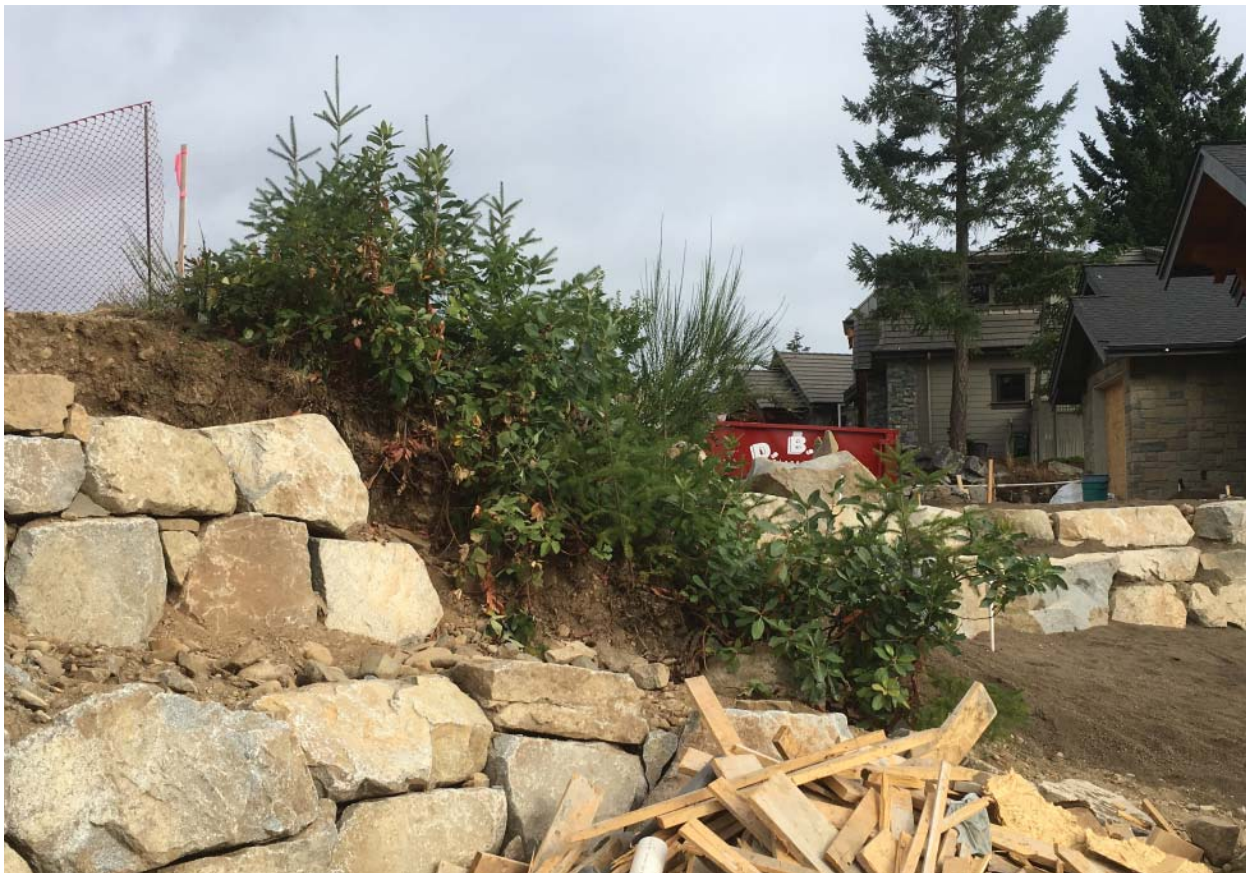
Image 2 (below):
Approximate 2m grade change
(existing vegetation) that would
require bank retention and stairs.
Adjacent bank retention by
neighbours visible.

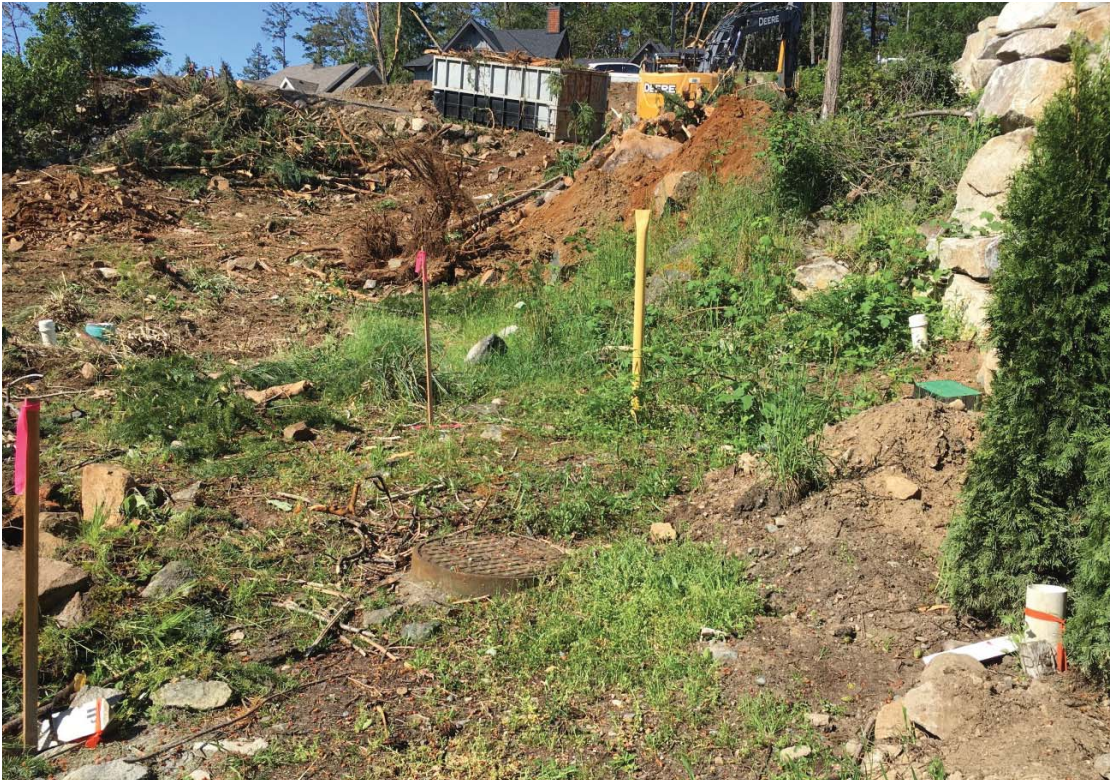
Image 3 (above): Facing west (towards Bonnington Dr.) RDN sewer infrastructure visible. Bedrock and grade change visible behind yellow pipe. Stair work in this area would require monitoring next to existing boulder retaining wall.

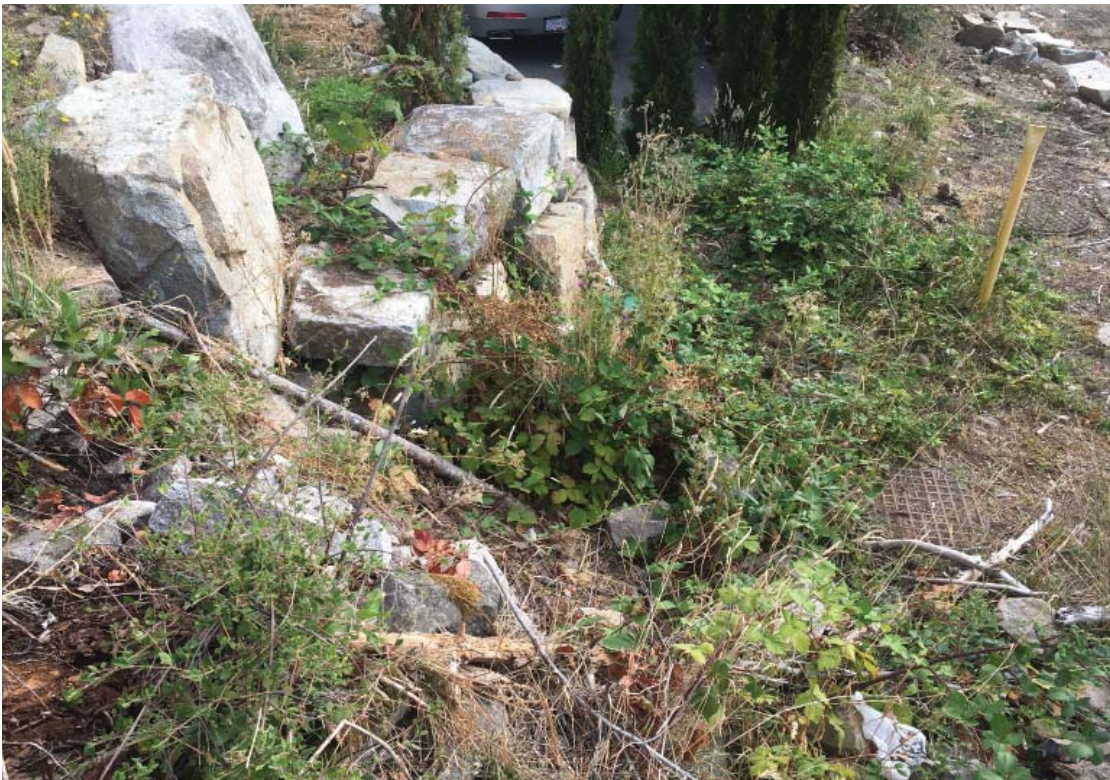
Image 4 (below): Facing east (towards Coventry Pl.) MOTI stormwater manhole visible. Stair landing placement would need to be setback from infrastructure.

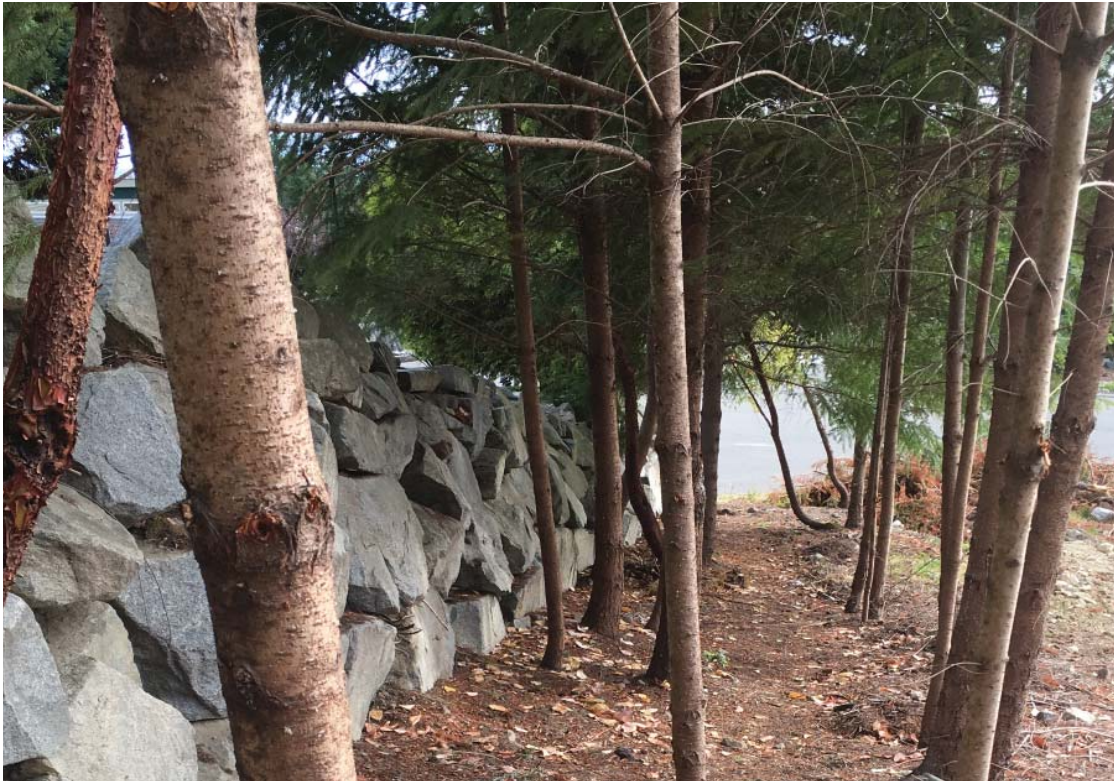
Image 5 (above): Small group of regenerating evergreen trees. One or two small diameter trees would require removal to open up walkway. Compatibility with underground infrastructure to be confirmed.
