BUILDING CONDITION ASSESSMENT REPORT

Little Qualicum Hall Building,
1210 Centre Road, Qualicum Beach BC

Submittal Date:
Nov. 27, 2017

HEL Project No. 0837-050

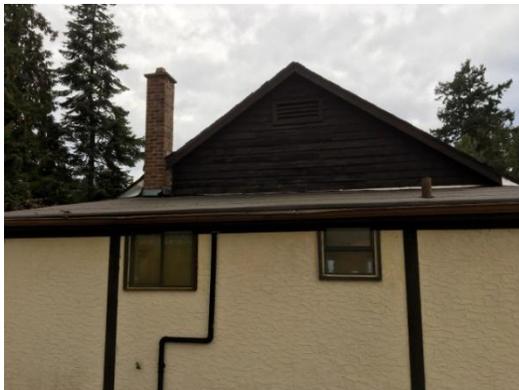
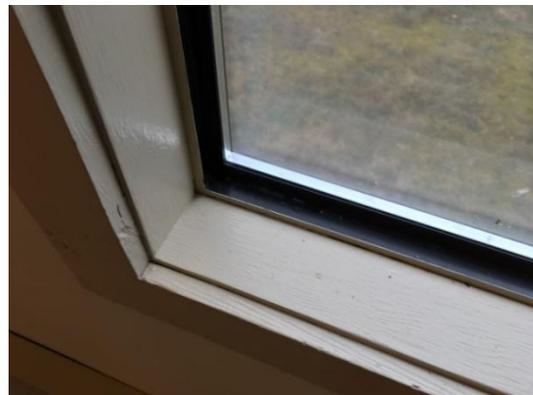
Most of the windows have an exterior plexi glass frame/covering, providing protection which has prevented severe weathering of the windows. While the frames and glazing continue to function as intended they are considered to have a very poor thermal performance with a high level of heat loss during the heating season.

Given the age of these assemblies, it is recommended that consideration be given to the replacement of the existing windows with assemblies that are compliant with current North American Fenestration Standard (NAFS) requirements with respect to thermal performance and air and water penetration requirements. It is advised that the replacement windows be installed in accordance with Best Practices for Window and Door Replacement in Wood-Frame Buildings, publication.
